**Immediate Response Action  
Status Report No. 3** (DEP RTN 3-  
23246) **and Immediate Response  
Action Status Report No. 1** (DEP  
RTN 3-26114)  
50 Tufts Street, Somerville, MA

Submitted to:  
**UniFirst Corporation**  
68 Jonspin Road  
Wilmington, MA 01887

Prepared by:  
**GEI Consultants, Inc.**  
400 Unicorn Park Drive  
Woburn, MA 01801  
781-721-4000

May 10, 2007, 2007

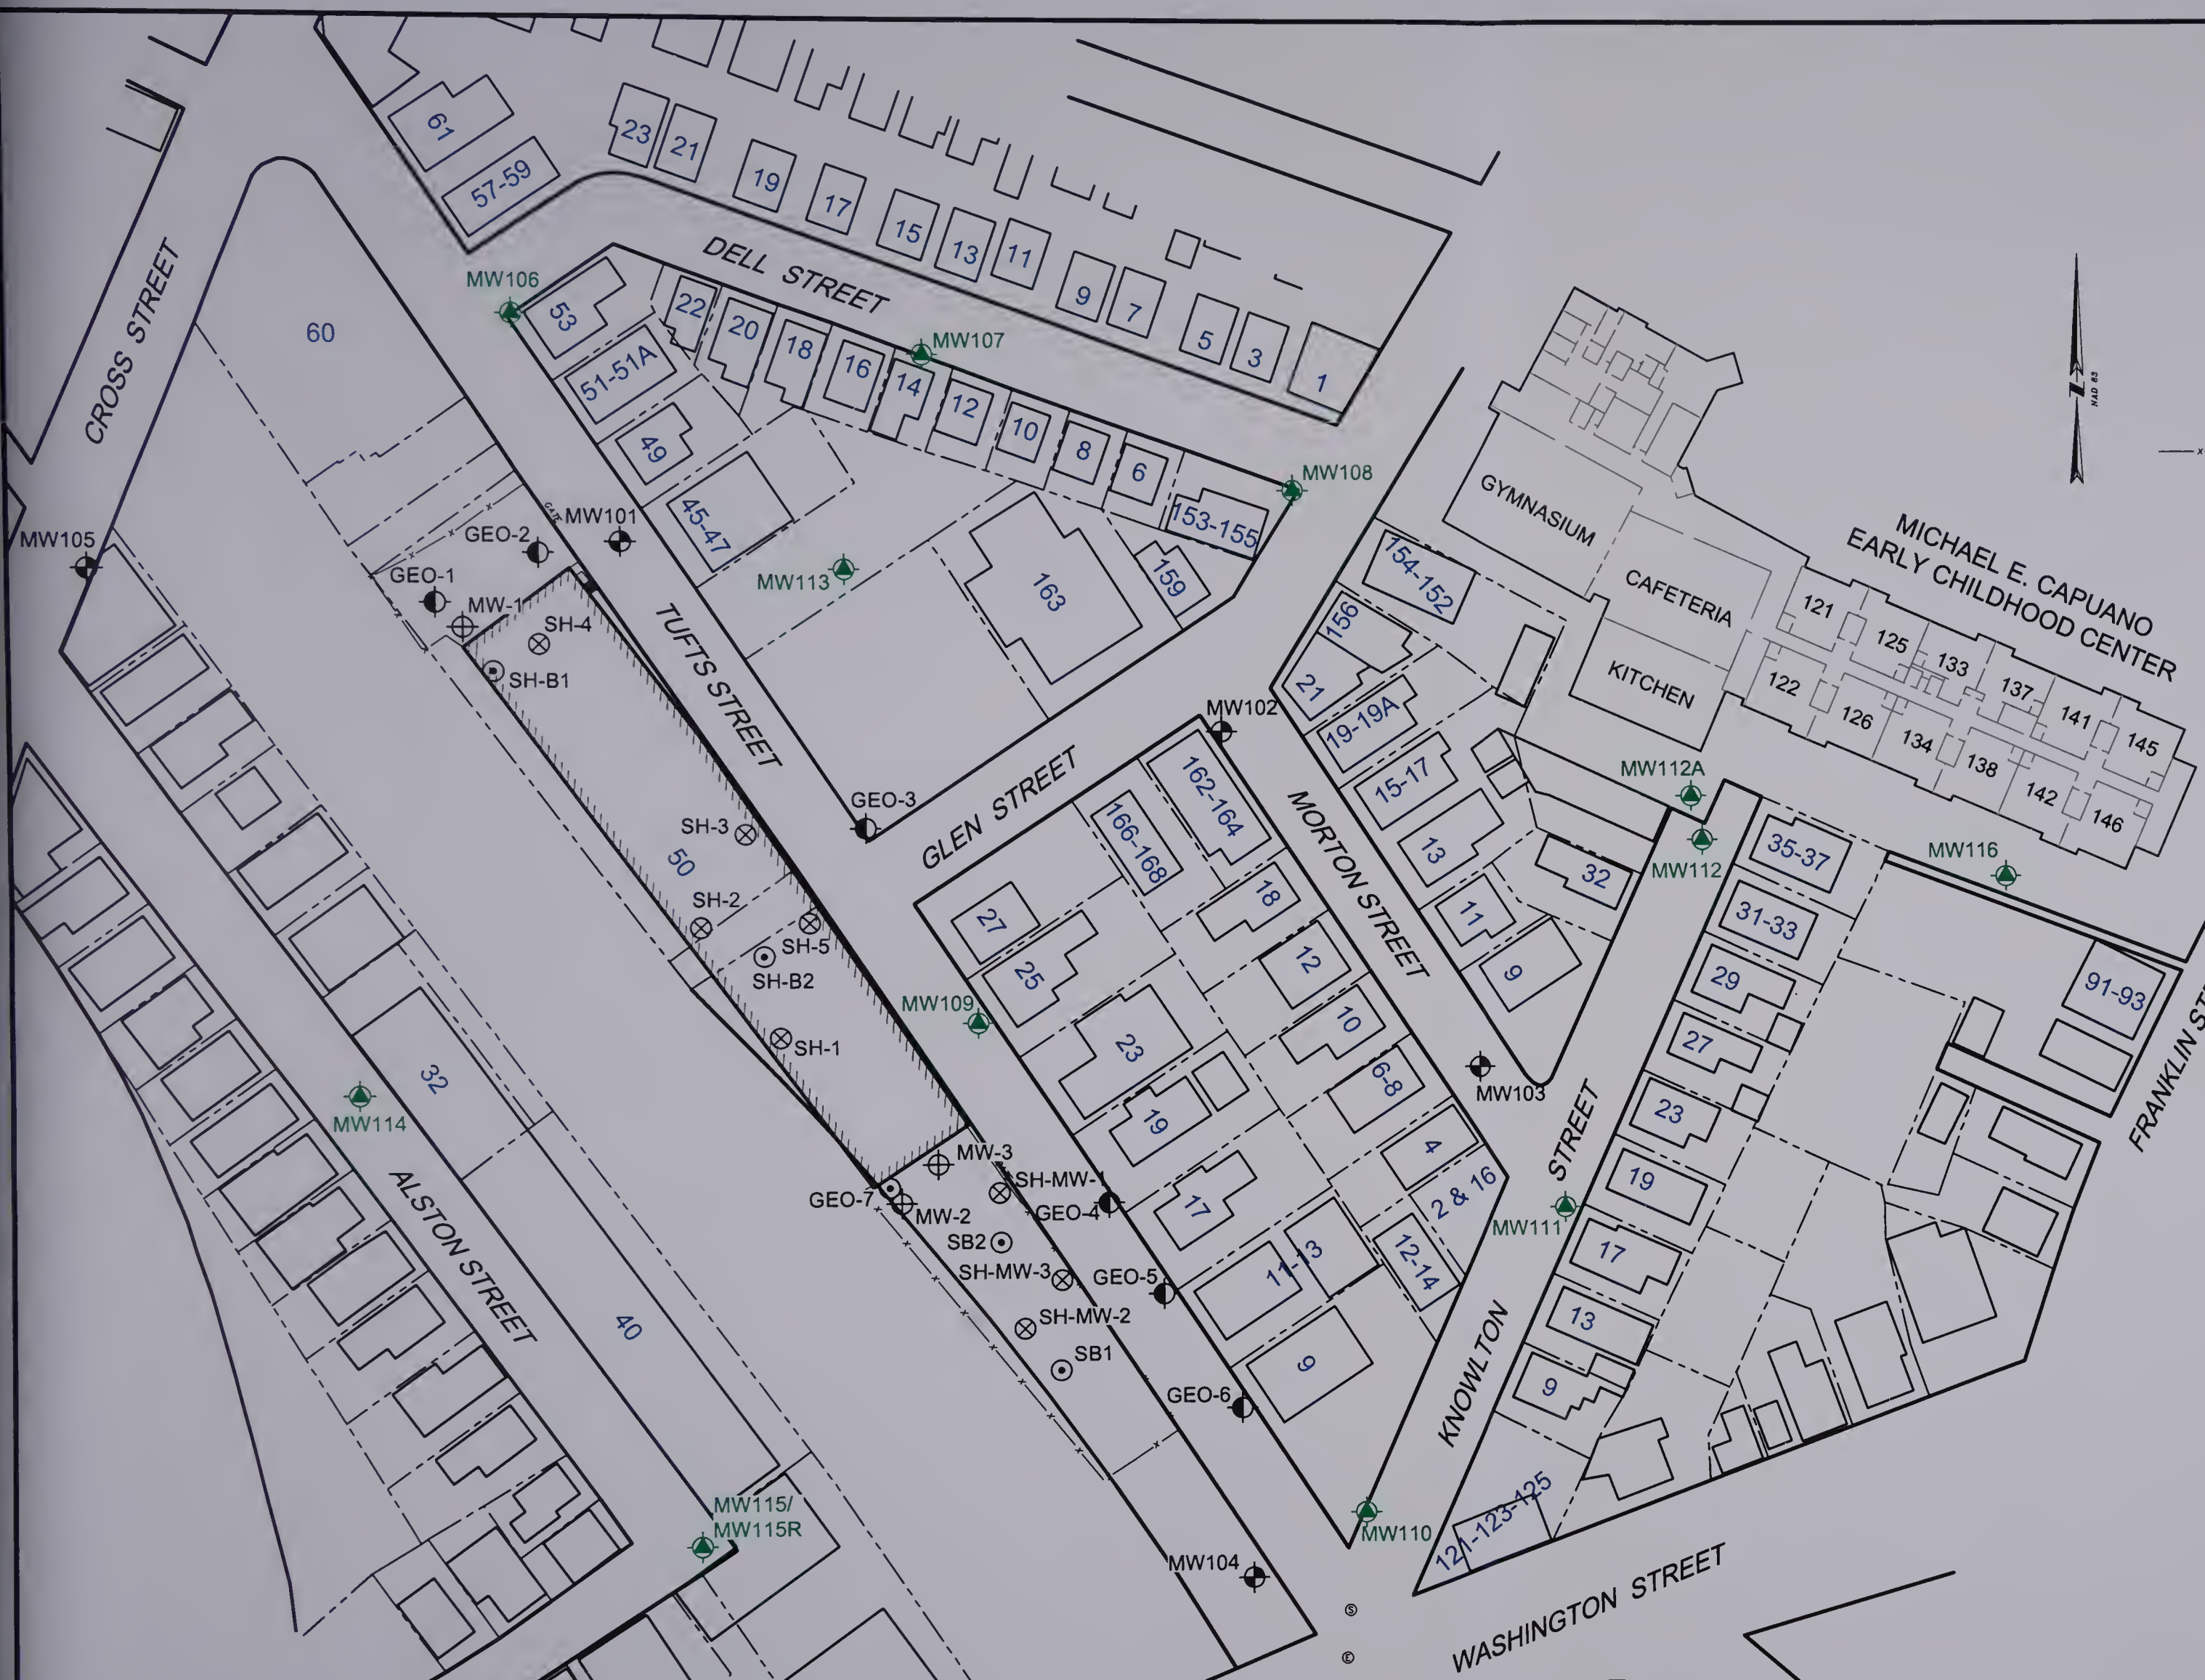
<p>IRA Status Report No.3 50 Tufts Street Somerville, Massachusetts</p>	<p><b>GEI</b> Consultants</p>	<p>MONITORING WELL AND BORING LOCATIONS</p>
<p>UniFirst Corporation Wilmington, Massachusetts</p>	<p>Project 04516-2</p>	<p>May 2007 <span style="float: right;">Fig. 22</span></p>

- MONITORING WELL WITH SOIL GAS SAMPLE PORT INSTALLED BY GEI, JANUARY - MARCH 2007
- MONITORING WELL INSTALLED BY SANBORN HEAD ASSOCIATES, 2002
- MONITORING WELL INSTALLED BY GEOINSIGHT, JUNE 2004
- SOIL BORING ADVANCED BY GEOINSIGHT, AUGUST 2004
- MONITORING WELL INSTALLED BY GEI, MAY 2006
- MONITORING WELL INSTALLED PREVIOUSLY, DATE UNKNOWN
- CHAIN LINK FENCE
- 138 ROOM NUMBER AT CAPUANO SCHOOL

Between January 4, 2007 and March 10, 2007, GEI observed Geosearch, Inc.(Geosearch) of Fitchburg, Massachusetts drill a total of 12 borings and complete them as groundwater monitoring wells at the Site. Monitoring well locations are shown in Figure 22. A summary of boring data and monitoring well construction is in Table 11. Boring logs and monitoring well installation reports are in Appendix J. The locations and elevations of the newly installed monitoring wells shown in Figure 22 were surveyed by BSC Group of Boston, Massachusetts on March 16 through 20, 2007.

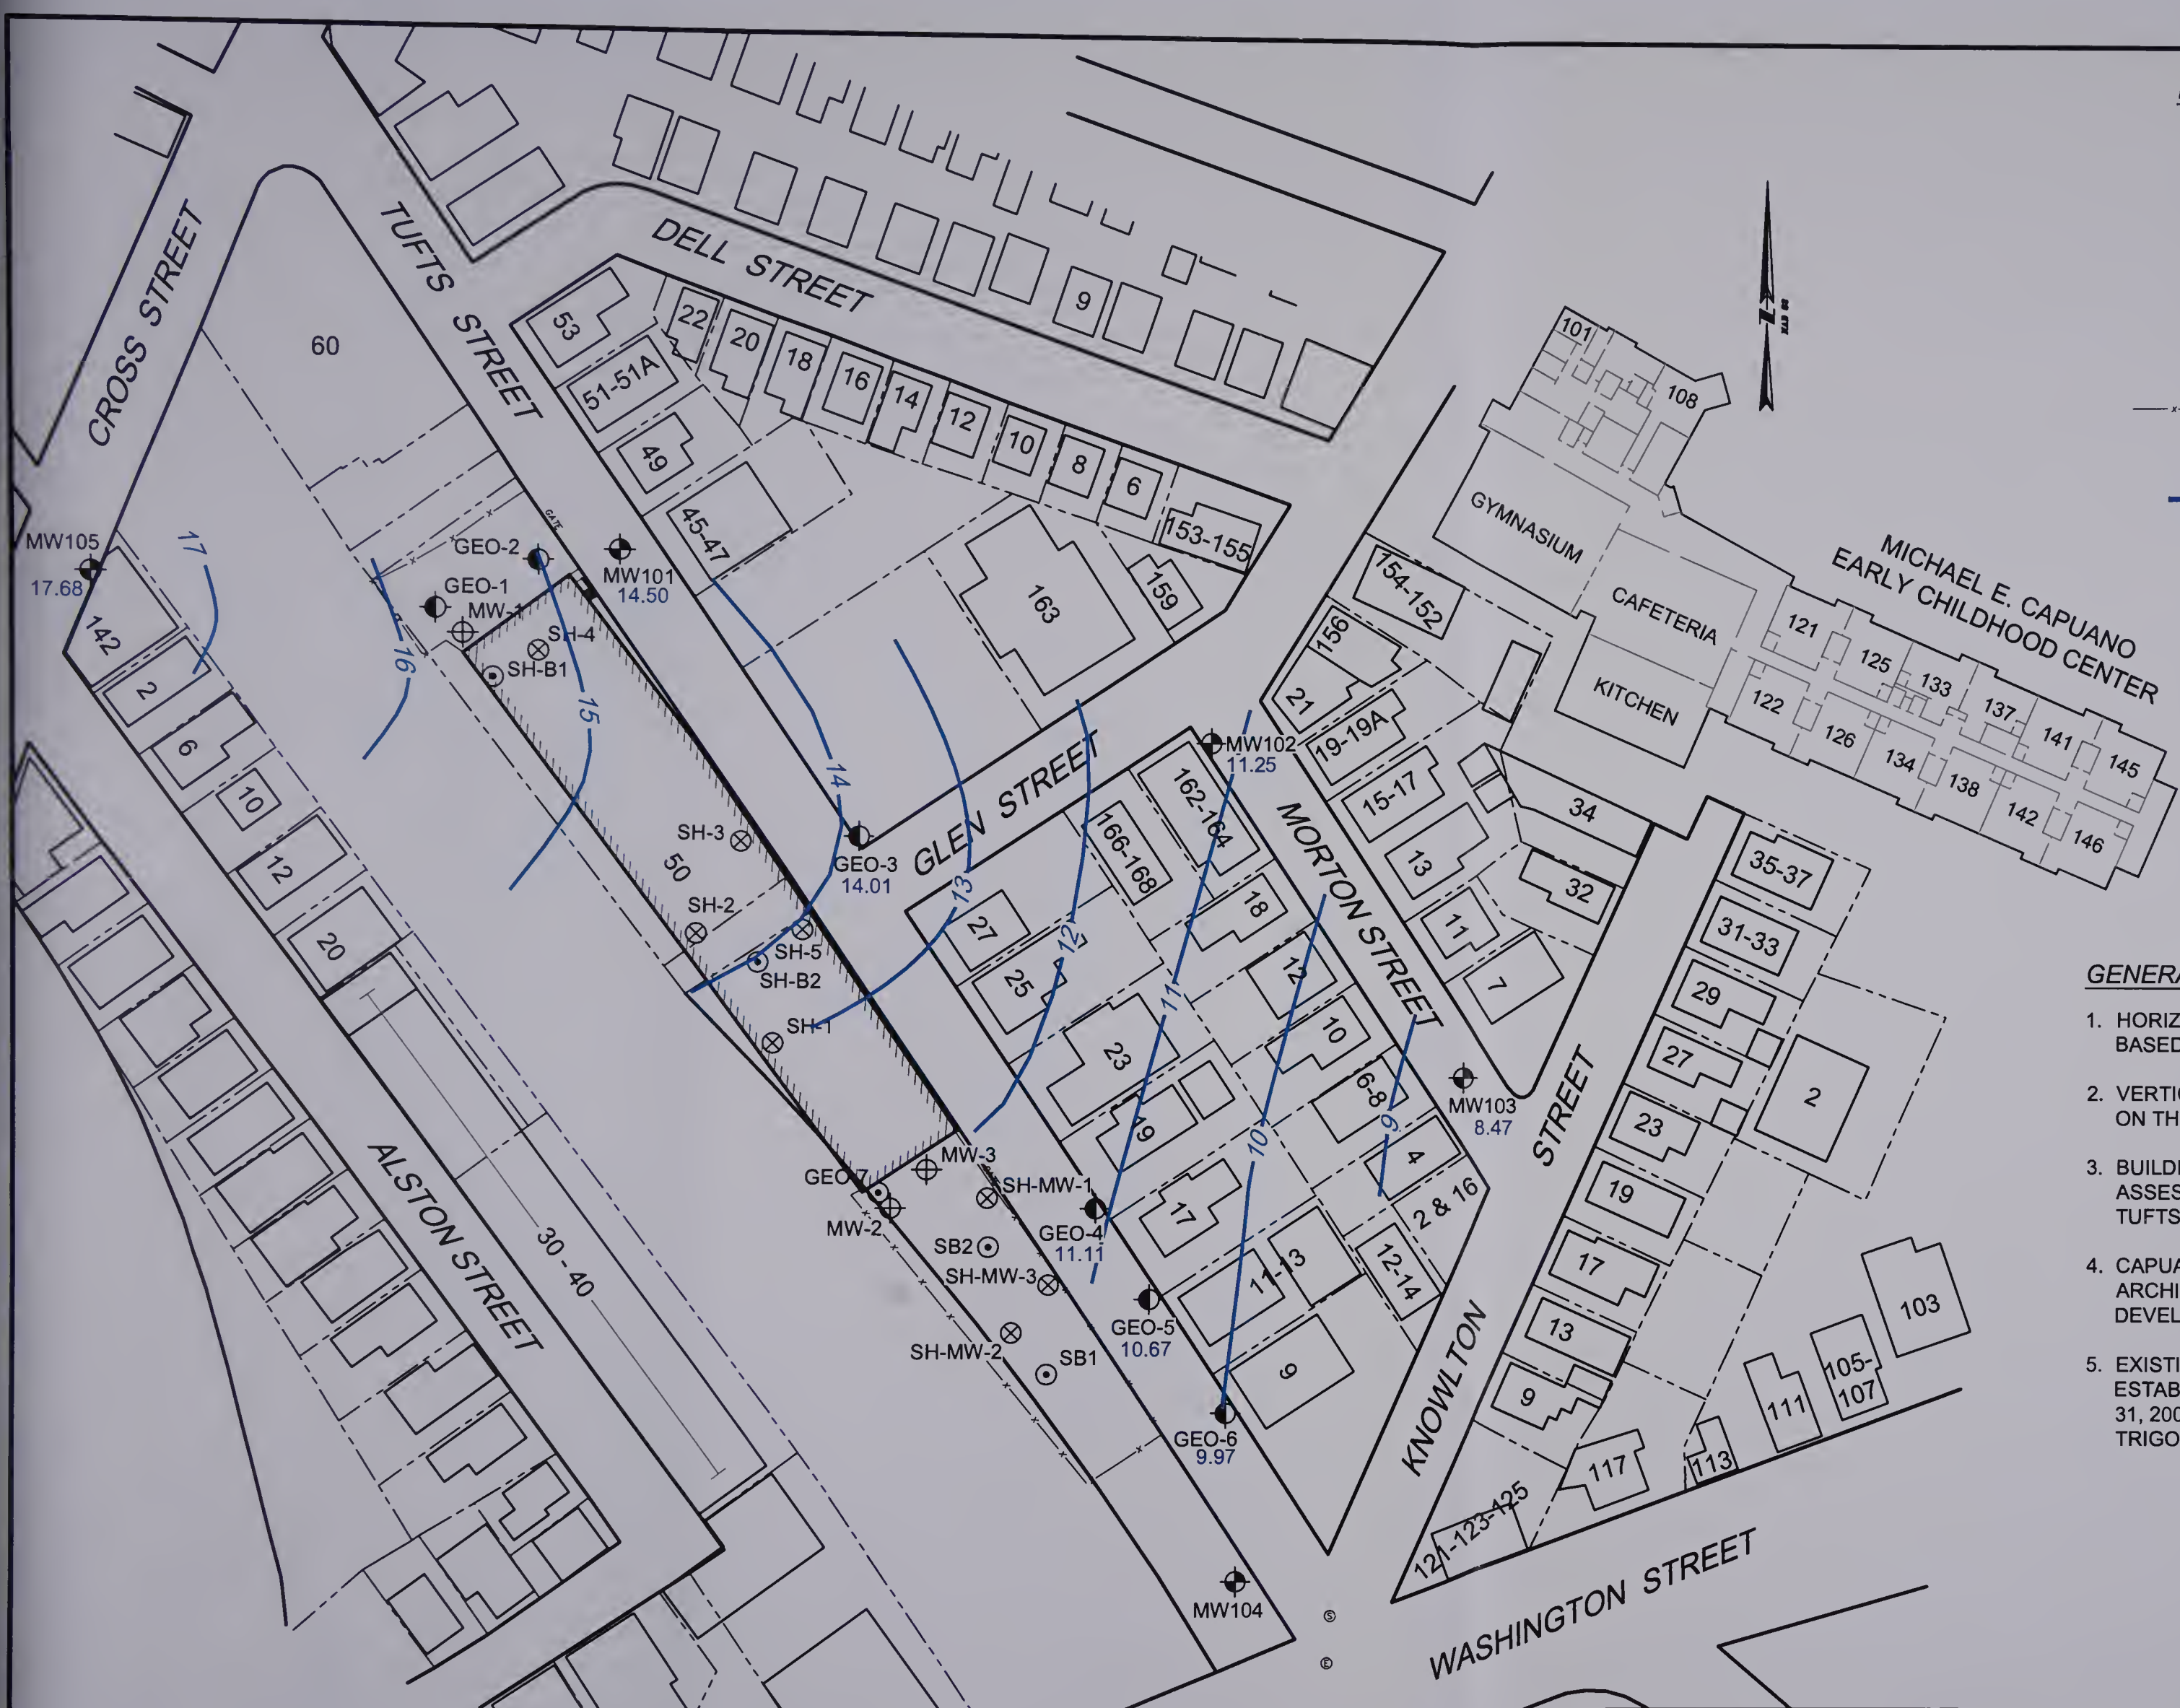
GROUNDWATER CONTOURS 11/14/06	
UniFirst Corporation Wilmington, Massachusetts			Project 04516-2	May 2007

- ⊗ MONITORING WELL INSTALLED BY SANBORN HEAD ASSOCIATES, 2002
- ⊙ MONITORING WELL INSTALLED BY GEOINSIGHT, JUNE 2004
- ⊙ SOIL BORING ADVANCED BY GEOINSIGHT, AUGUST 2004
- ⊙ MONITORING WELL INSTALLED BY GEI, MAY 2006
- ⊕ MONITORING WELL INSTALLED PREVIOUSLY, DATE UNKNOWN
- x — CHAIN LINK FENCE
- 15.35 GROUNDWATER ELEVATION (FEET) NOVEMBER 14, 2006
- 15 — INFERRED SHALLOW OVERBURDEN GROUNDWATER ELEVATION CONTOUR (FEET)

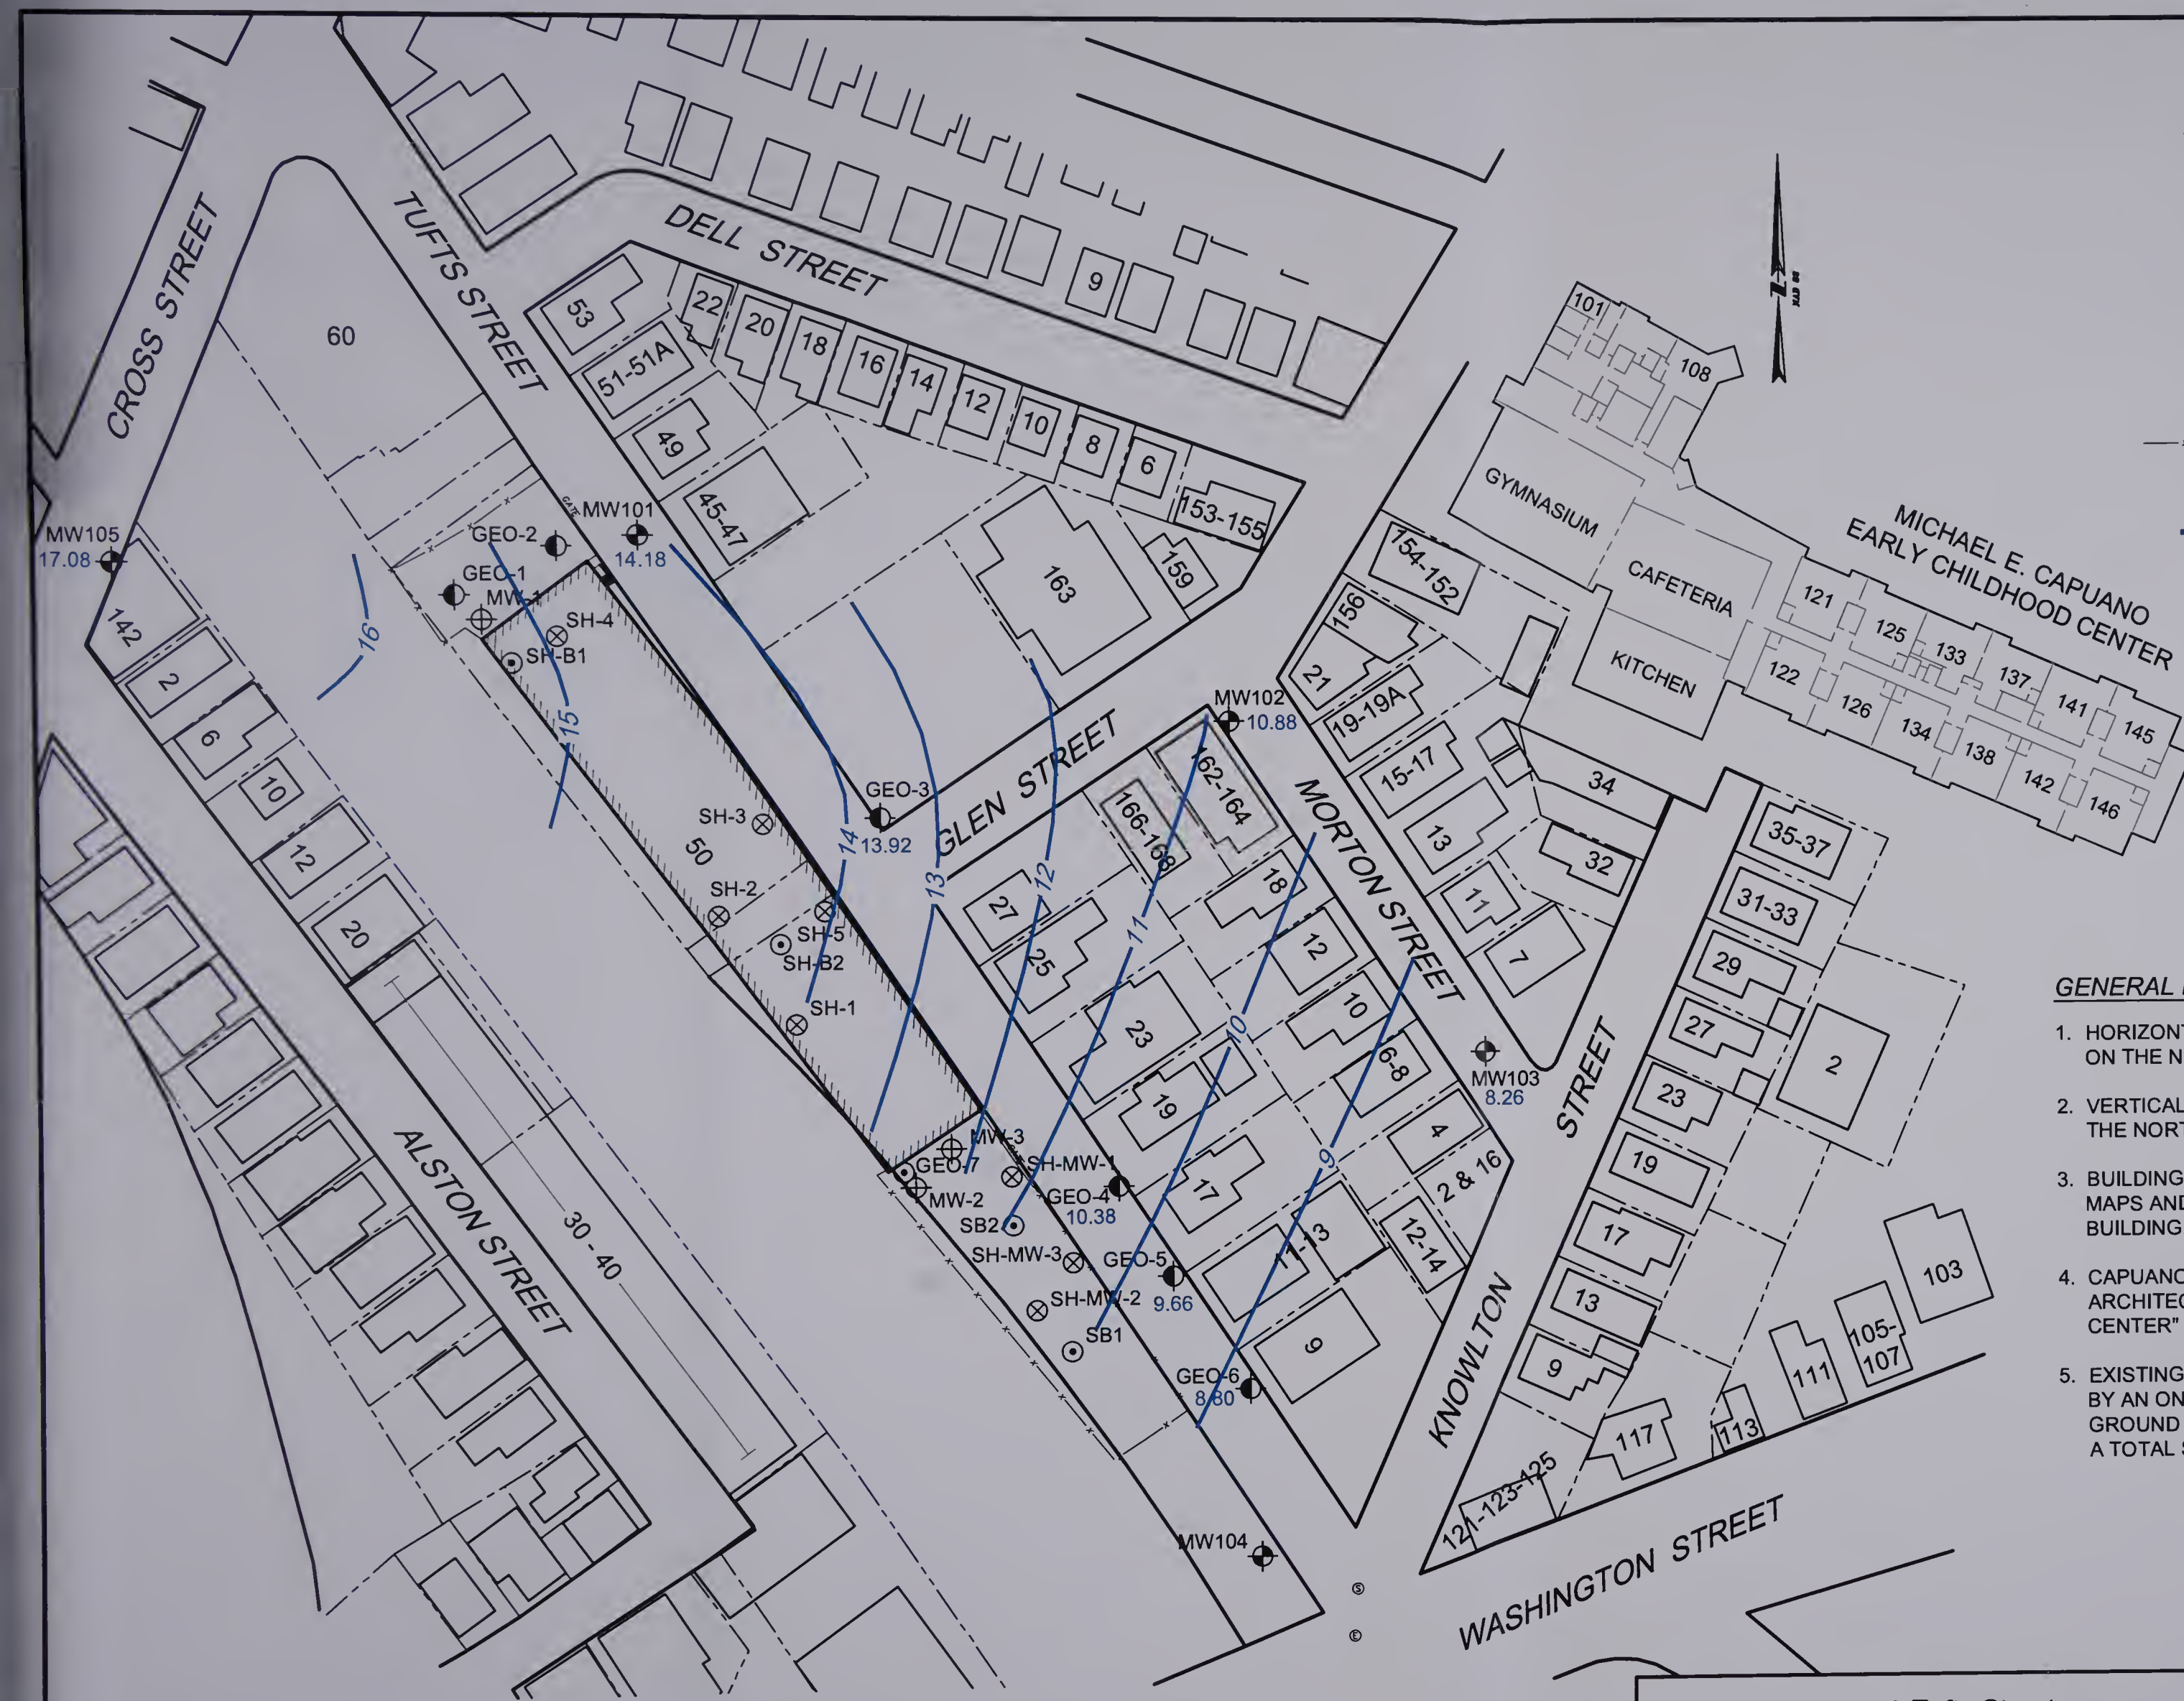
GROUNDWATER CONTOURS 12/12/06	
UniFirst Corporation Wilmington, Massachusetts			Project 04516-2	May 2007

- ⊗ MONITORING WELL INSTALLED BY SANBORN HEAD ASSOCIATES, 2002
- MONITORING WELL INSTALLED BY GEOINSIGHT, JUNE 2004
- ⊙ SOIL BORING ADVANCED BY GEOINSIGHT, AUGUST 2004
- ⊕ MONITORING WELL INSTALLED BY GEI, MAY 2006
- ⊕ MONITORING WELL INSTALLED PREVIOUSLY, DATE UNKNOWN
- CHAIN LINK FENCE
- 15.35 GROUNDWATER ELEVATION (FEET) DECEMBER 12, 2006
- 15 INFERRED SHALLOW OVERBURDEN GROUNDWATER ELEVATION CONTOUR (FEET)

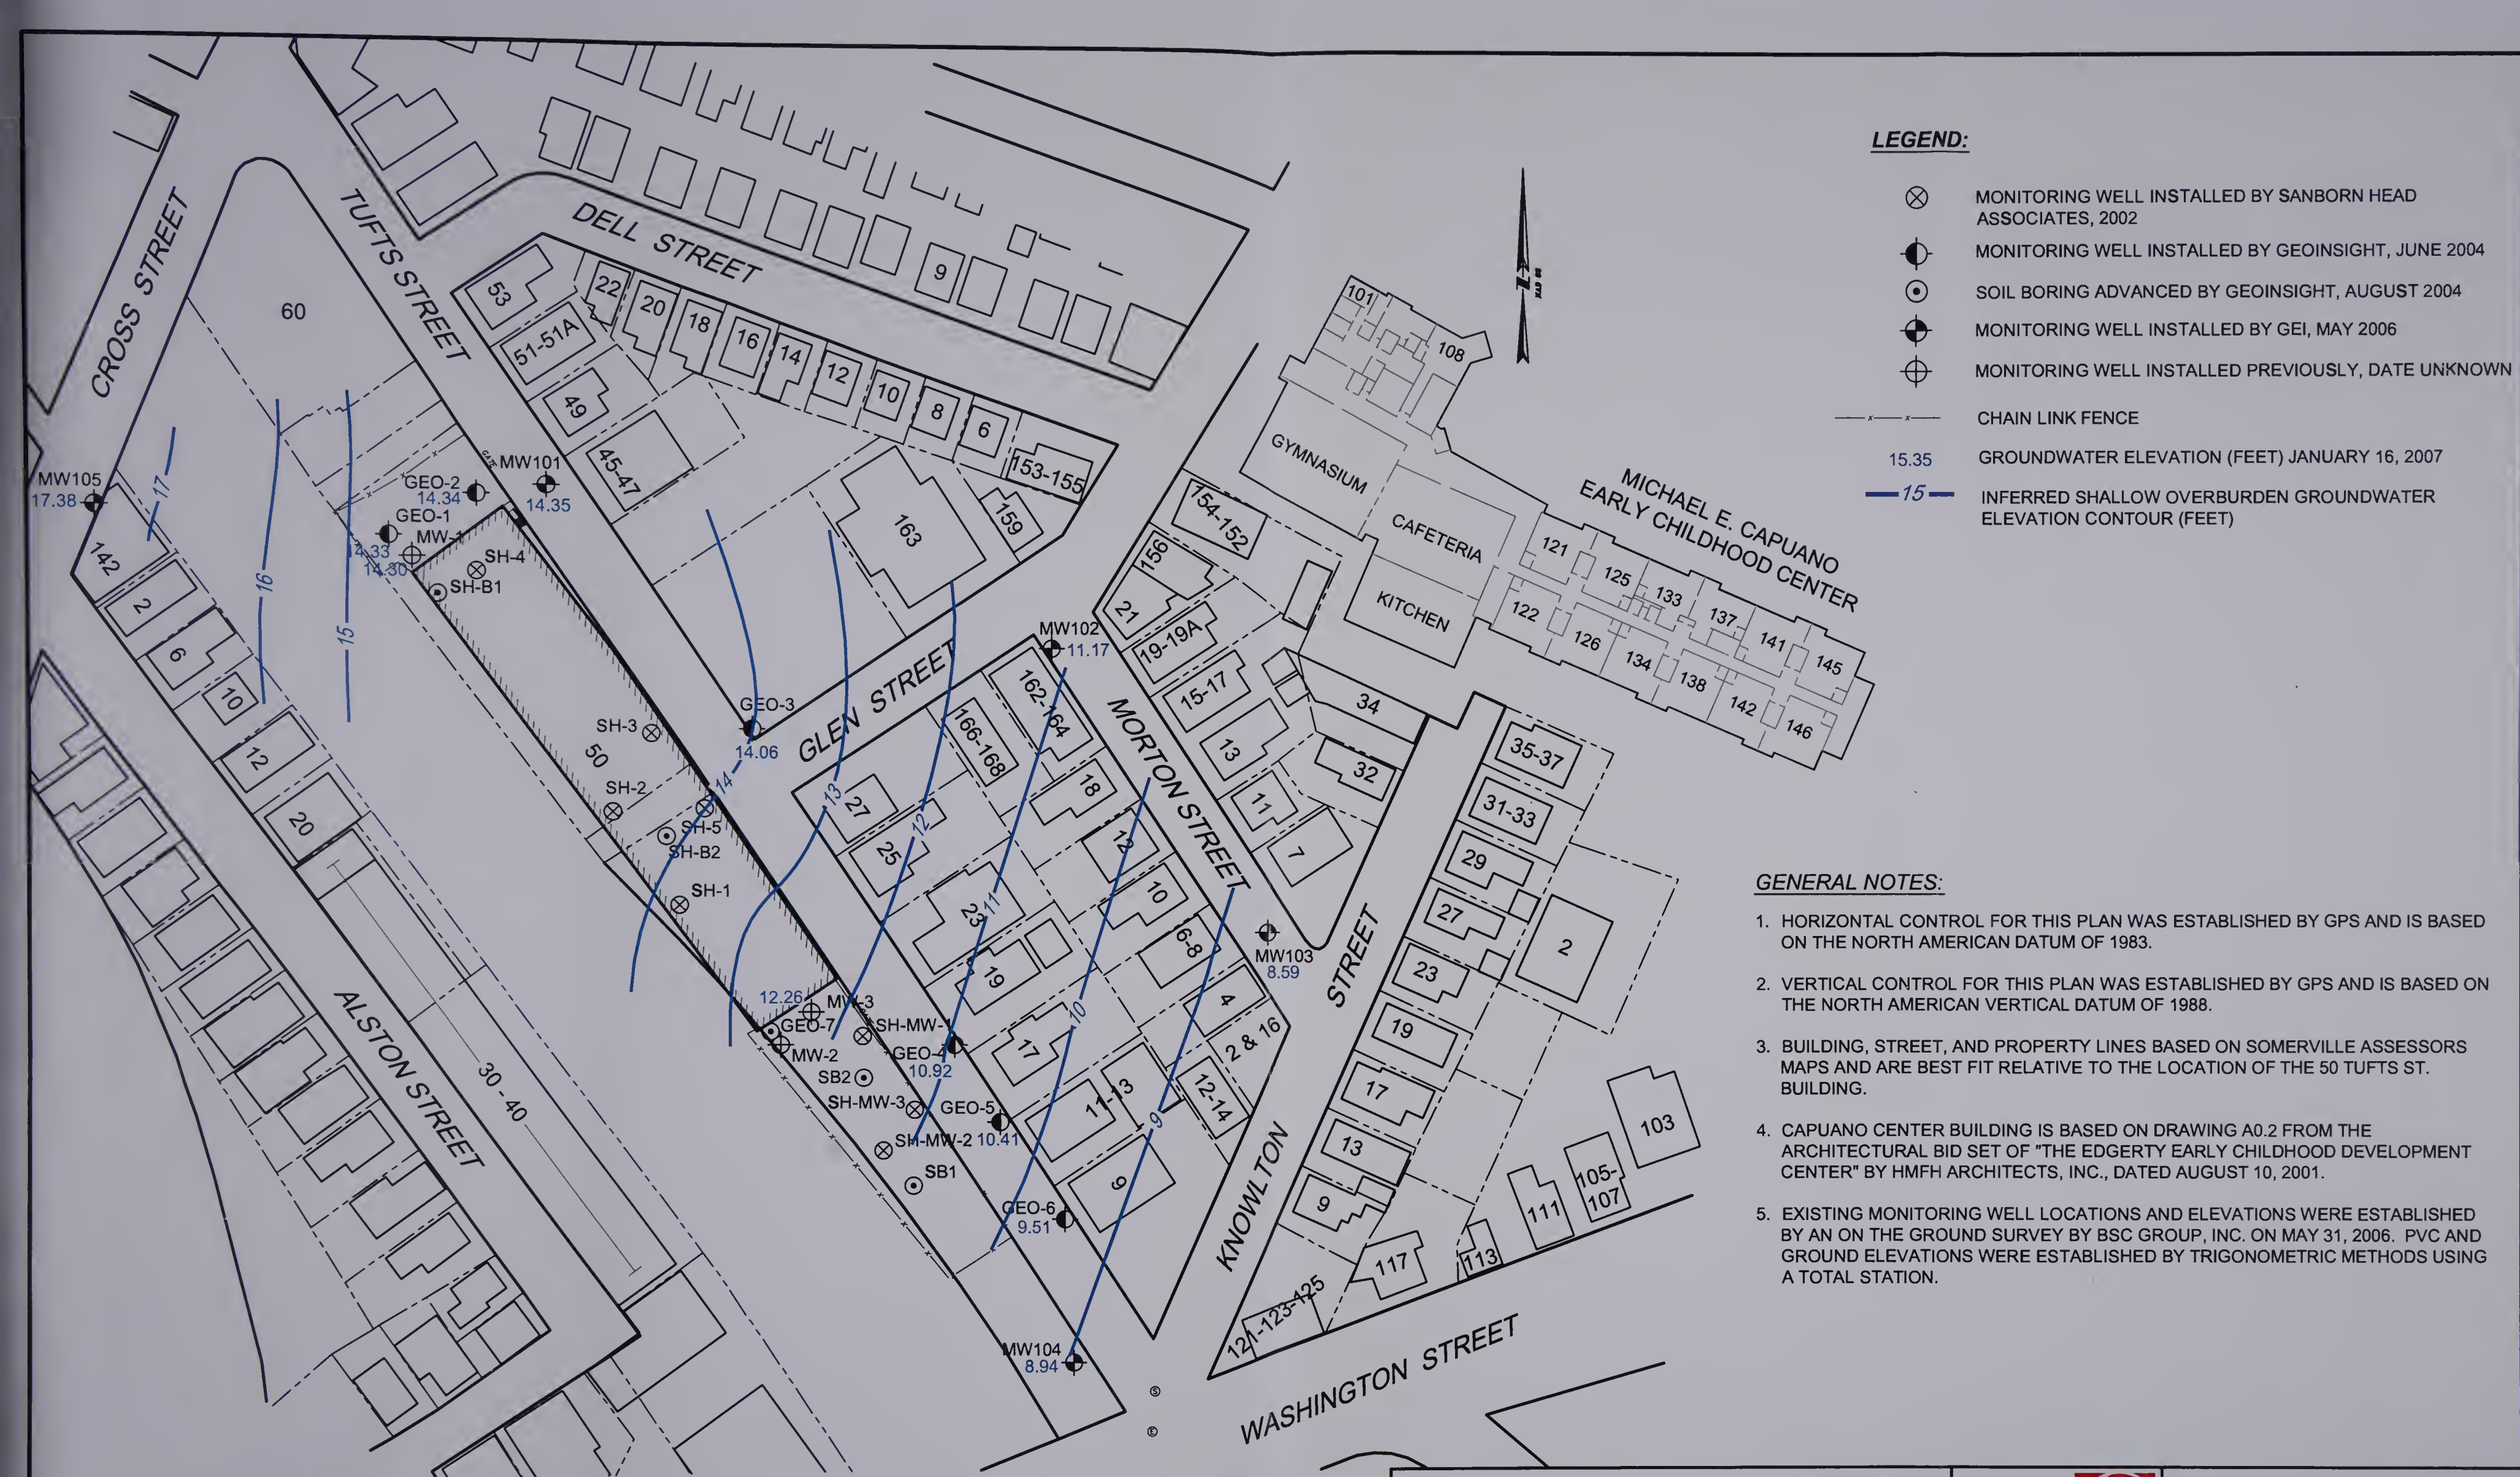
GROUNDWATER CONTOURS 1/16/07	
UniFirst Corporation Wilmington, Massachusetts			Project 04516-2	May 2007

- ⊗ MONITORING WELL INSTALLED BY SANBORN HEAD ASSOCIATES, 2002
- ⊙ MONITORING WELL INSTALLED BY GEOINSIGHT, JUNE 2004
- ⊙ SOIL BORING ADVANCED BY GEOINSIGHT, AUGUST 2004
- ⊙ MONITORING WELL INSTALLED BY GEI, MAY 2006
- ⊙ MONITORING WELL INSTALLED PREVIOUSLY, DATE UNKNOWN
- x — CHAIN LINK FENCE
- 15.35 GROUNDWATER ELEVATION (FEET) JANUARY 16, 2007
- 15 — INFERRED SHALLOW OVERBURDEN GROUNDWATER ELEVATION CONTOUR (FEET)
